Manhole Inspection Summary

Manhole # S45EE_055MH

Location Address: **1822 E. Chase St.**

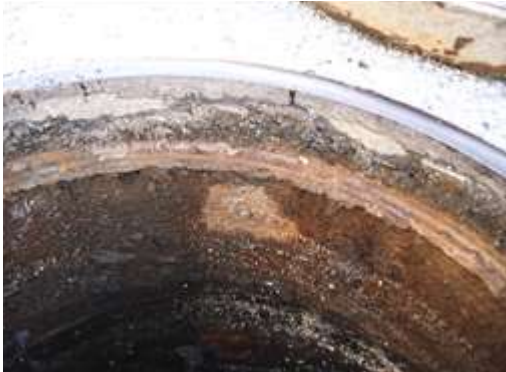
Defect 1

Frame Offset: **0** (in.) Condition: ☐ Sound ☐ Cracked ☒ **Leaks**

frame leaks
